**CONFIDENTIAL INSPECTION REPORT**

123 Abc St., St. Marys, GA 31558

11/8/2011 2:00 pm to 5:30 pm

# SUMMARY REPORT

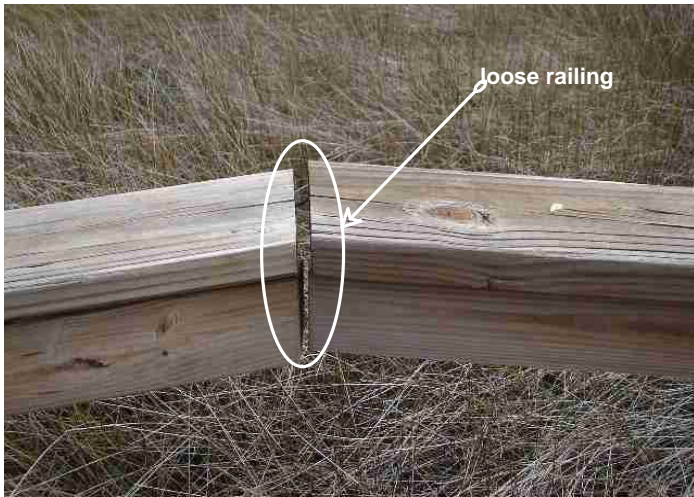
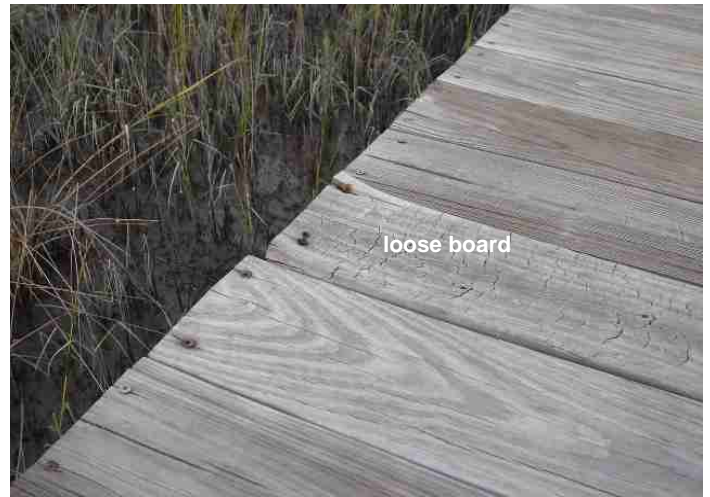
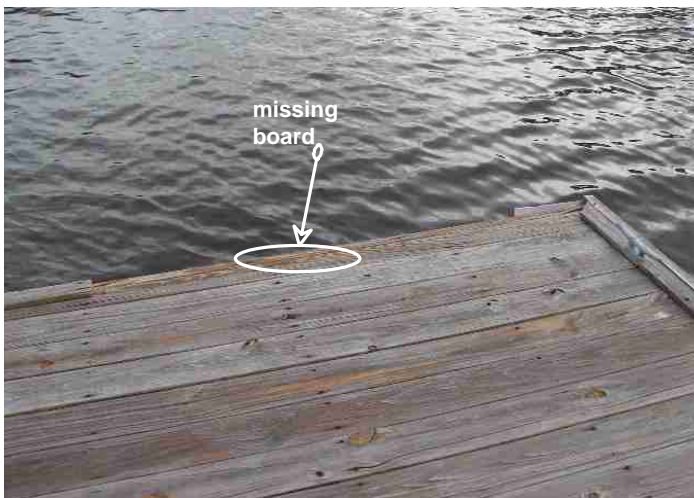
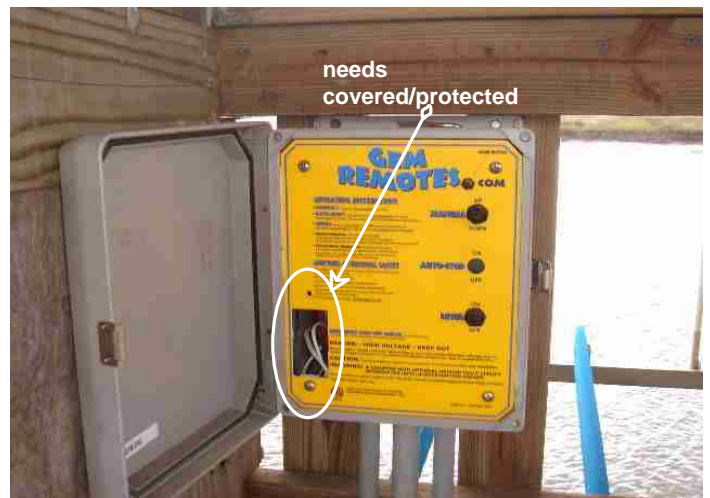
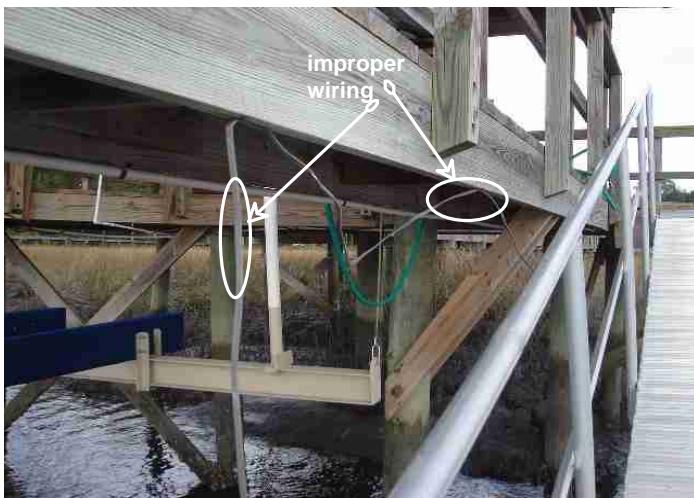
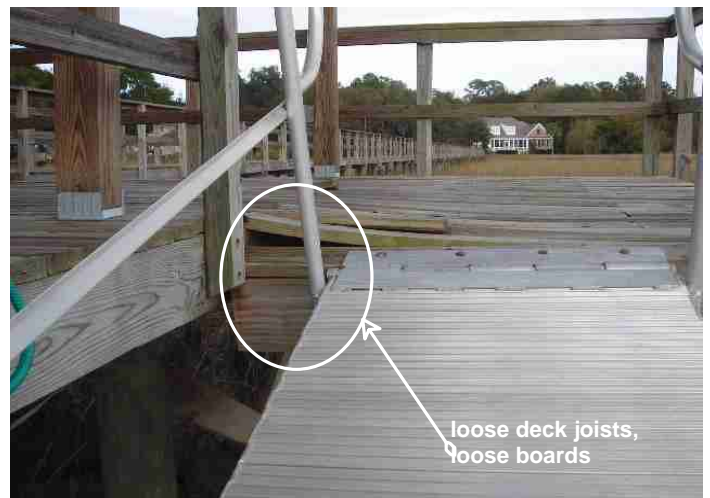
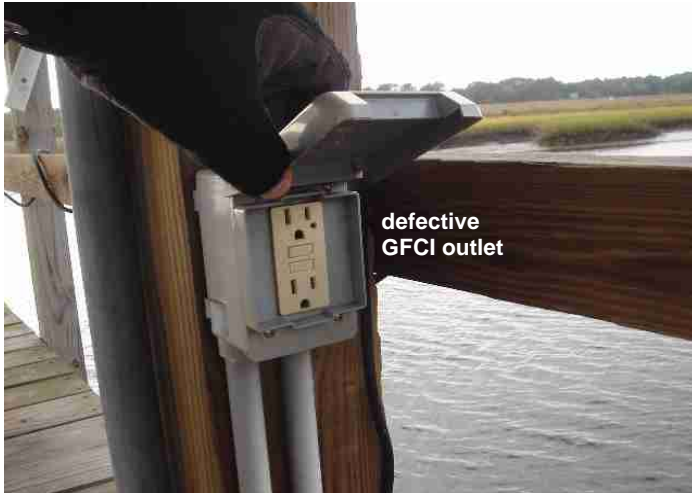
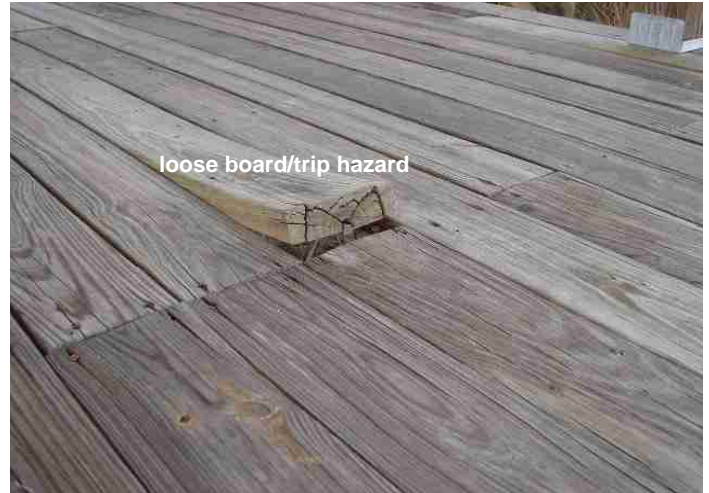
- 2.1 - Inspection of docks including floating portion are limited to what is visible above the water level. Further evaluation by a specialist is advised. However following issues were noted on what is visible and accessible: loose boards and missing fasteners were noted at various areas; loose railing; missing edge board on the floating dock; portion of the deck joists detached at the top of the ramp; wiring for the floating dock light is exposed and should be installed in a conduit (portion of it was installed in a conduit); fan blades are missing; GFCI outlet is defective and should be replaced; opening in the boat lift control box should be covered.

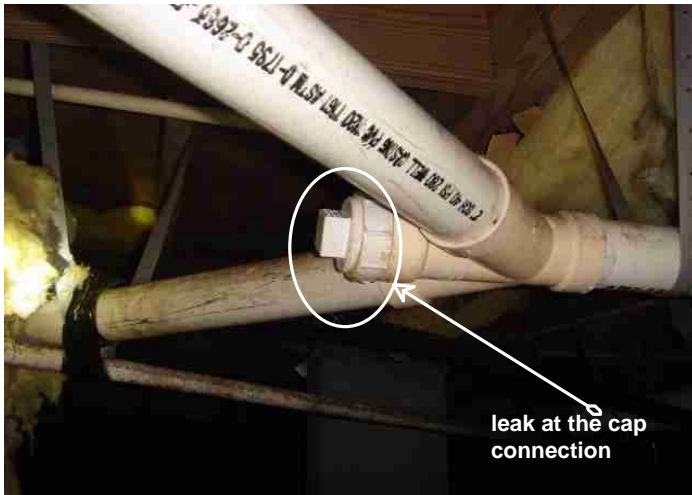
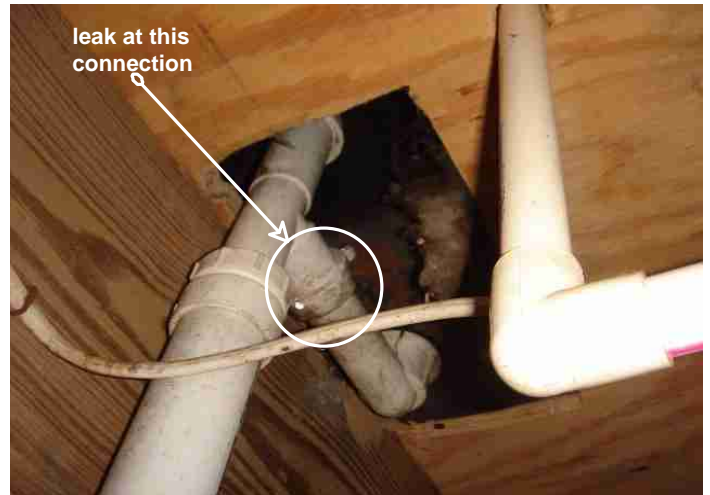
4.3 - There are drainpipe leaks at the following locations which should be repaired: cap connection at the master bathroom tub and stall shower drain pipes are connected to Y connection; Jack and Jill Bathroom bathtub drain line.

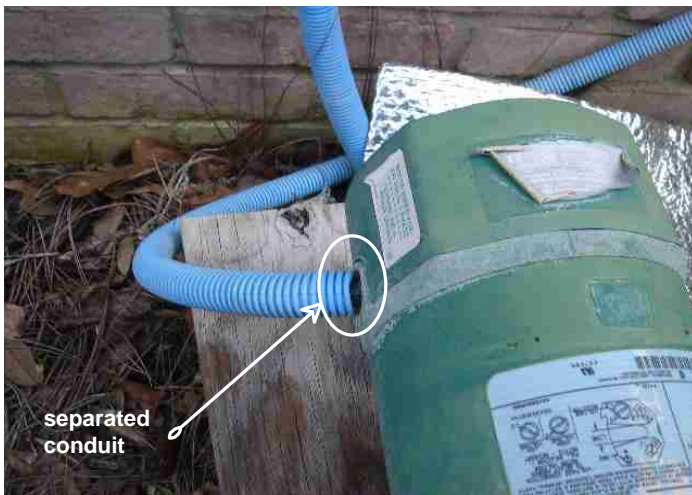
4.4 - Electric wire conduit is separated at the pump connection, which does not have proper clamp and should be serviced.

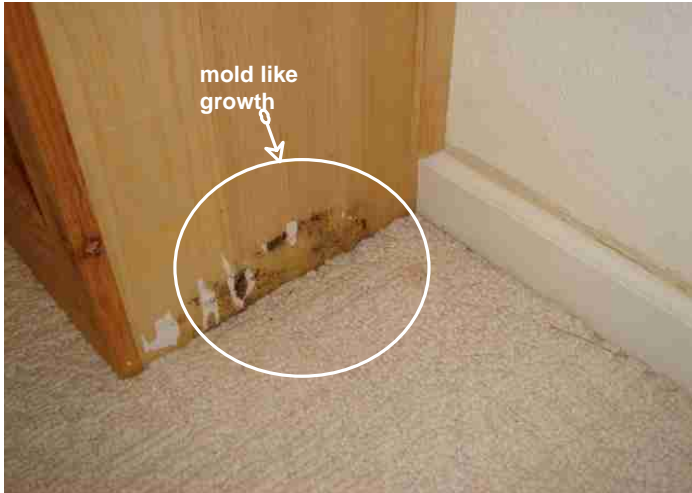
9.1 - There is a mold like growth on the side of the shelf near the window, which should be disinfected.

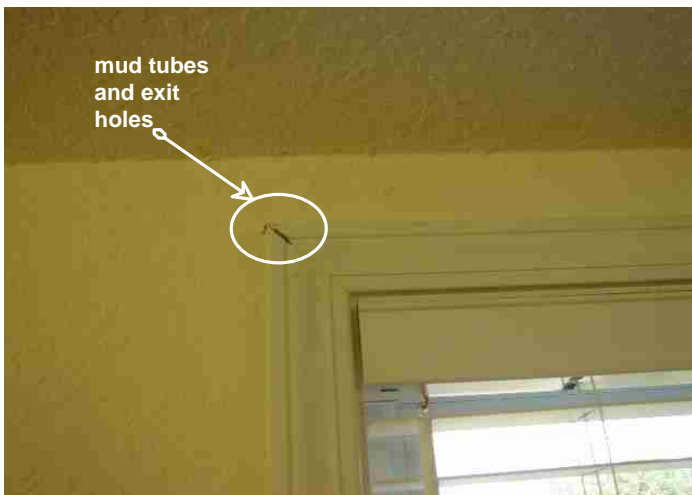
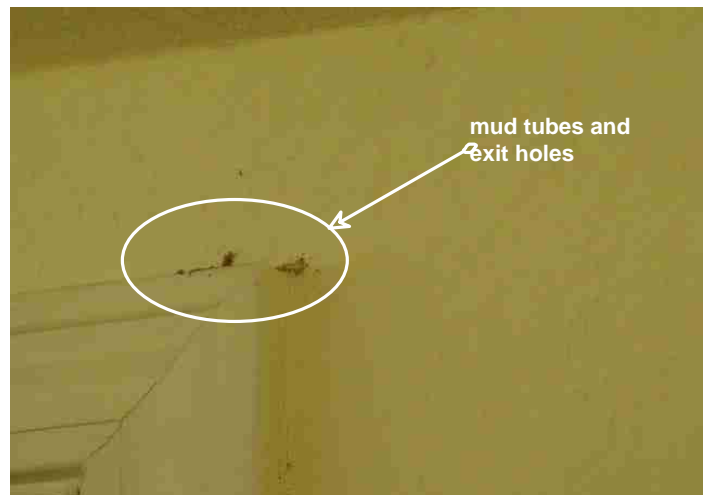
9.2 - There is evidence of wood borers in Bonus Room which should be further evaluated by a WDO inspector (exit holes and mud tubes on the wall above and below the window; mud tubes on the window trims; exit holes at wall and ceiling intersections). Area is not visible from attic due to vaulted ceiling.

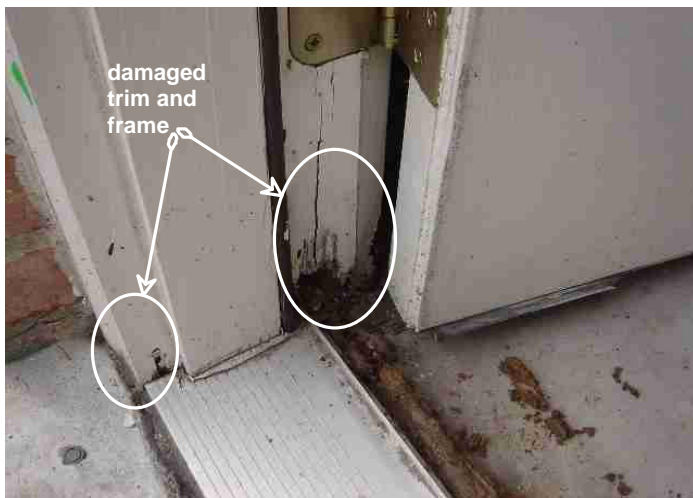
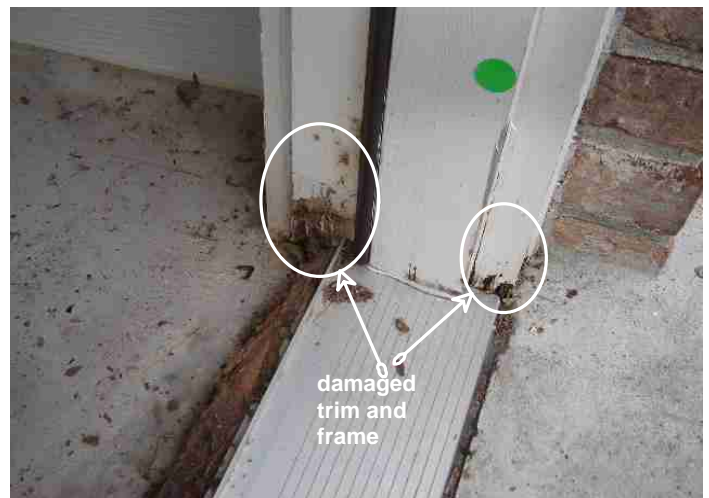
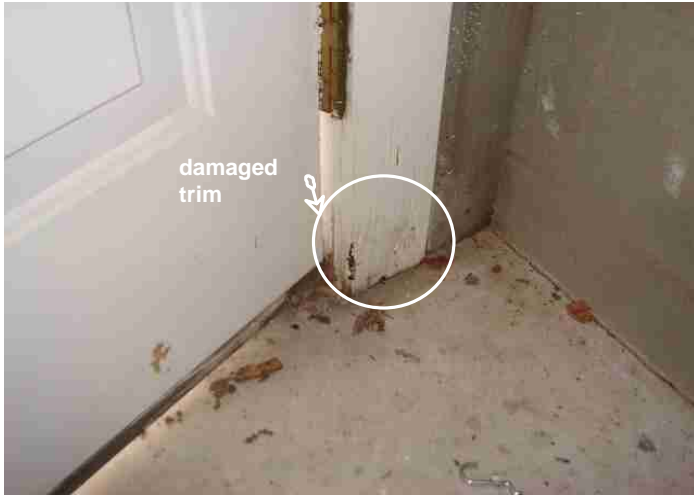
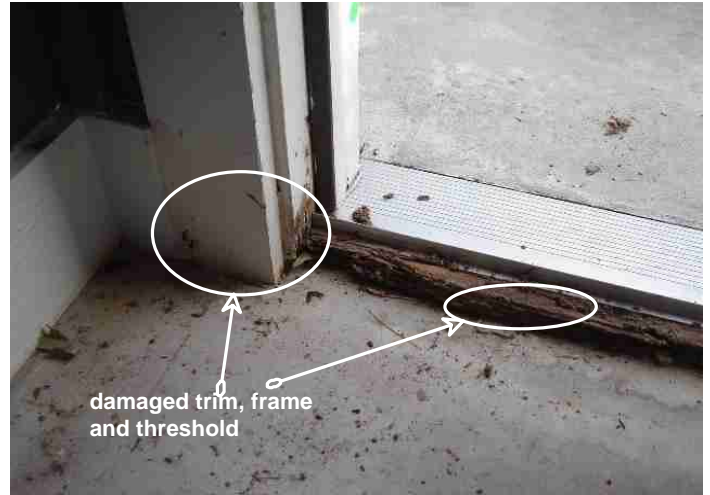
16.2 - Wood borer damage was noted to the frame, trim and threshold of the garage side door which should be further evaluated by a licensed WDO inspector.
