CONFIDENTIAL INSPECTION REPORT

123 Abc St., St. Marys, GA 31558

11/8/2011 2:00 pm to 5:30 pm

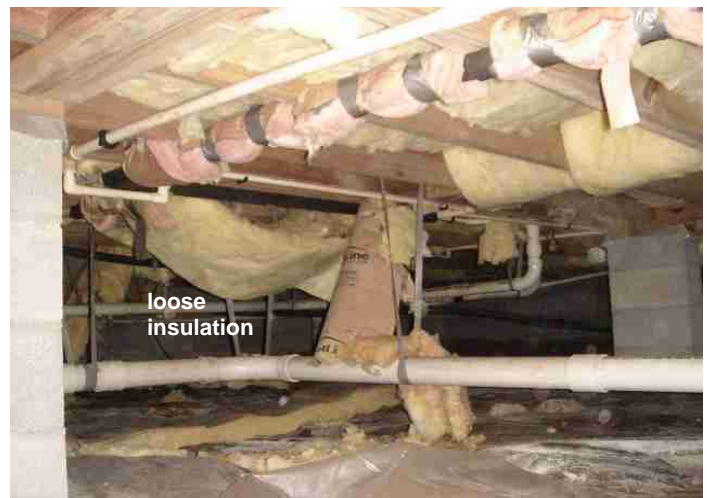
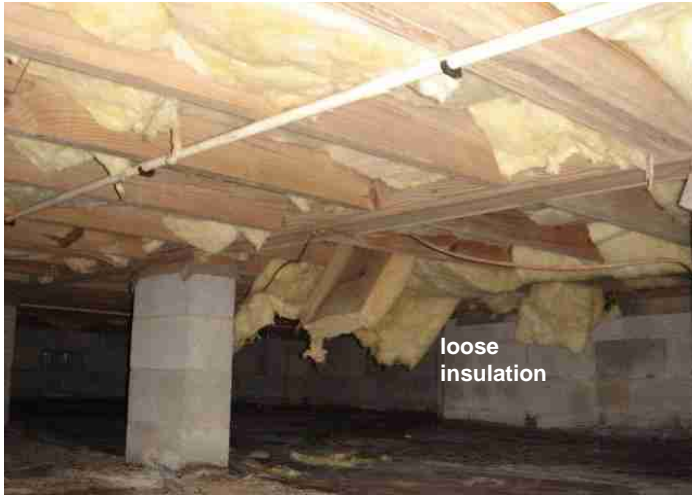
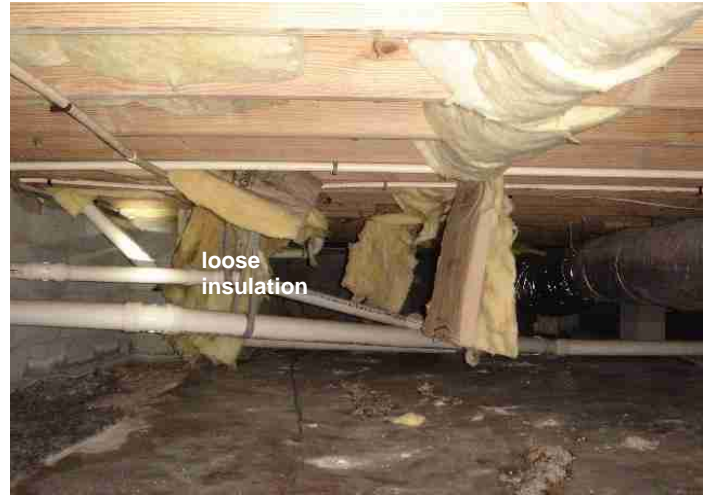
1.14 - Some pieces of insulation are hanging or have fallen from between the floor joists. This does not have any serious consequences, but you may wish to have it serviced.

Some pieces of insulation are hanging or have fallen from between the floor joists - *Continued*

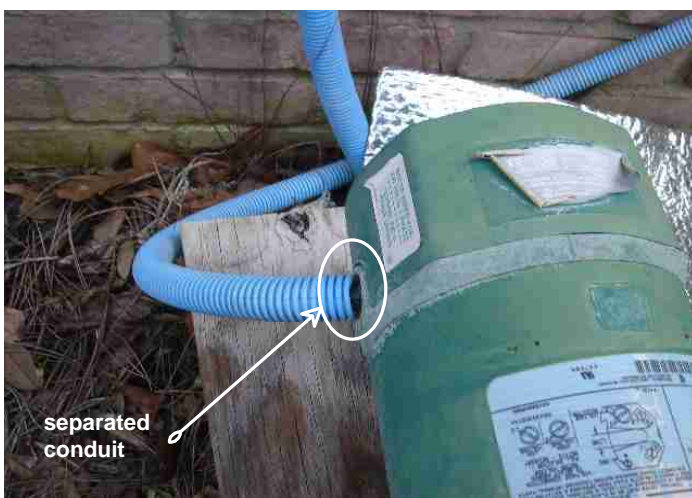
4.30 - Electric wire conduit is separated at the pump connection, which does not have proper clamp and should be serviced.
